Report on Remedial Works & Inspection of Residential Dwellings at Dolphin House, Dublin 8

**Report on Remedial Work and Inspection of
Residential Dwellings at Dolphin House,
Dublin 8**

Rialto Rights In Action Group

DOCUMENT AMENDMENT RECORD**Client:** Rialto Rights In Action Group**Project:** 6072**Title:** Report on Remedial Work and Inspection of Residential Dwellings at Dolphin House, Dublin 8

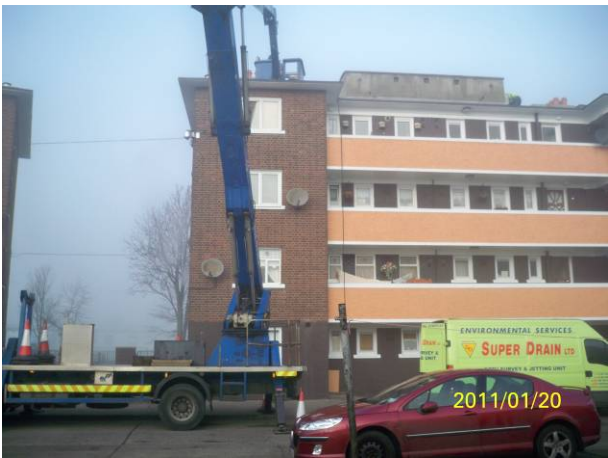
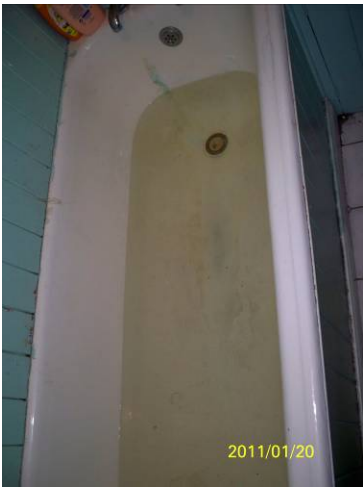
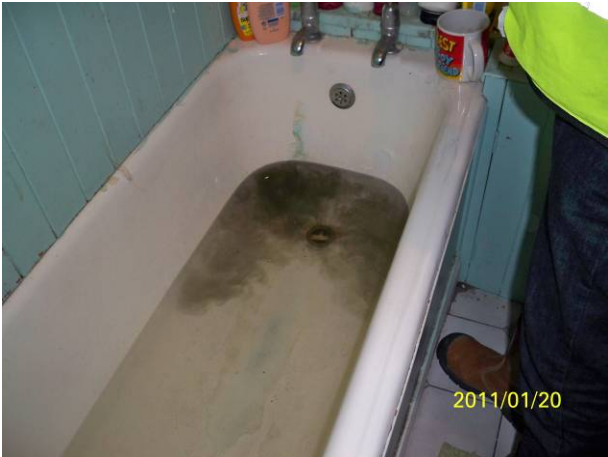
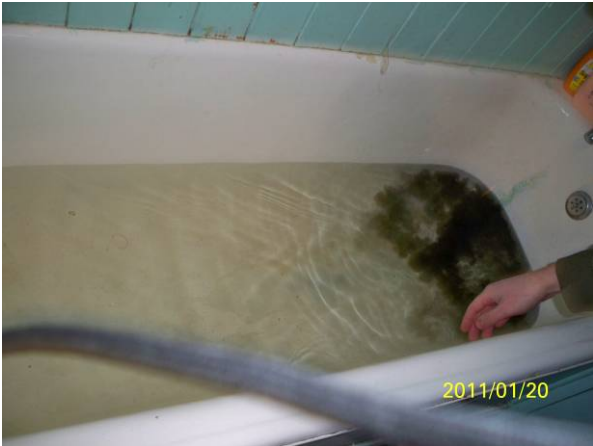
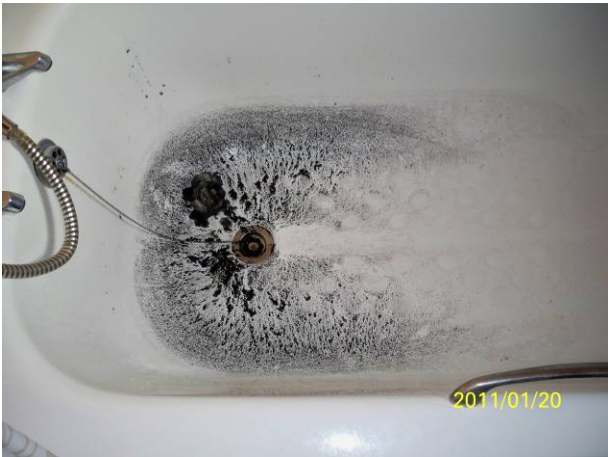
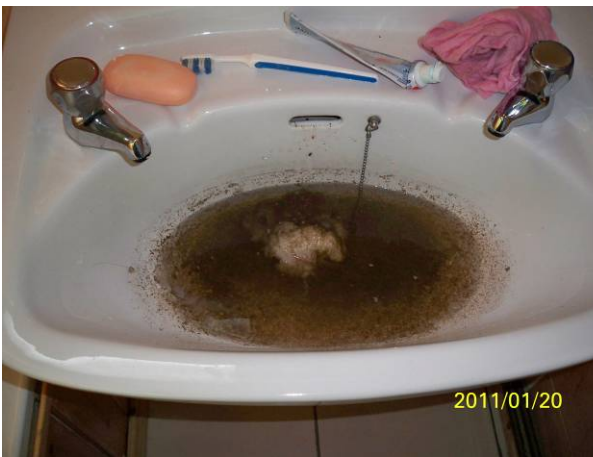
UNITS 16; 20; 24 & 28 JETTING & CLEANING

expected, a small amount of backflow was produced at each unit as the jetting proceeded past each unit. The following photographs illustrate the amount of backflow produced as a result of this operation. The CCTV following the cleaning operation could not proceed past approximately 2m, which may indicate the blockage is indeed due to an uncharted connection in this case.

In conclusion, it appeared that this method unblocked the collection stack, thereby increasing the capacity of the stack and decreasing the likelihood of backflow. Although not conclusive, it would appear that backflow is primarily due to blockage of the collection stack (notwithstanding the possibility that there is a blockage towards the top of the collection stack).

It would appear that the operation was a success and that backflow (and corresponding problems such as odour) is likely to be eliminated. TOBIN would recommend that this procedure be continued in this fashion in consultation with the residents.

Although jetting is unlikely to be a permanent solution it should provide a maintenance free solution for the medium term (5 to 10 years). Where uncharted connections are discovered, it is recommended that these be replaced or permanently blocked up.

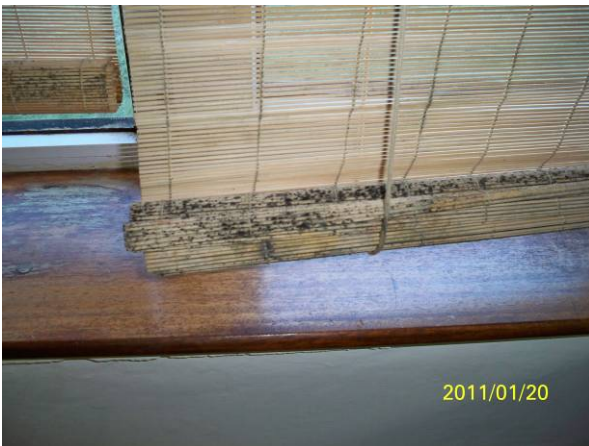
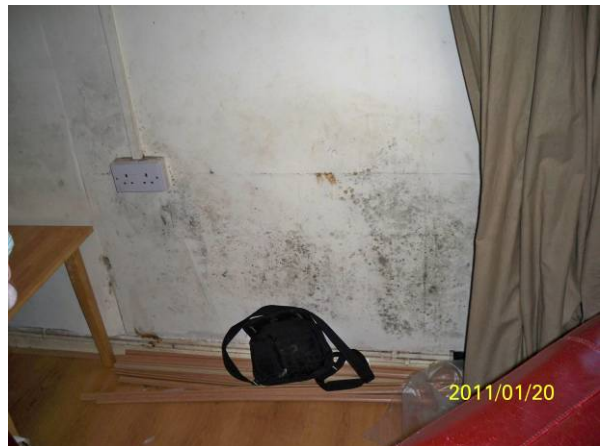
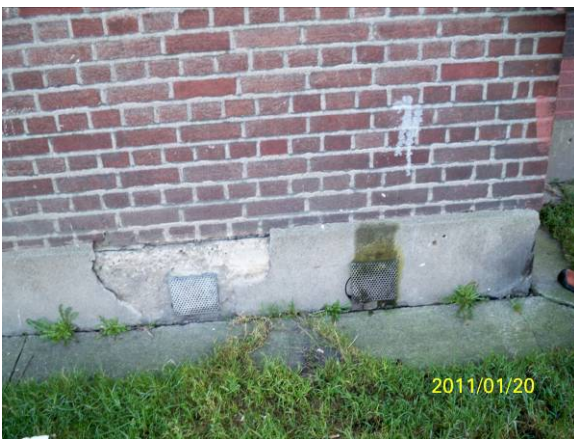
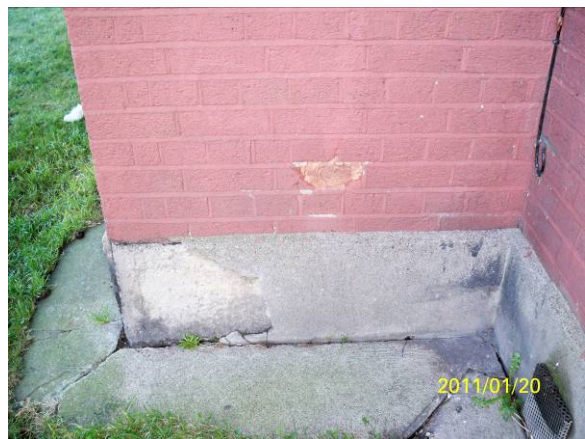
MOULD - UNIT 16

On completion of the Jetting and Cleaning operation above, a number of units were inspected in Rialto Rights in Action Group). There is no doubt that mould is indeed present within all units inspected and photographic evidence of attendance with Mr. Brian Curran, Dublin City Council and Mr. Rory Hearne and Ms. Sarah O'Keeffe (the mould within each unit is illustrated on the following pages.

It would appear that the main source of damp (and the consequent mould growth) is due primarily to condensation. There may be an element of penetrating damp entering the units but this should be eliminated with the reinstatement of the plinth, in particular to cover the DPC.

At present, it is Dublin City Council's policy that condensation is a Tenants responsibility. It is probably unlikely that condensation can be completely eliminated from the affected units. Therefore, it will be necessary to manage the condensation on an individual unit basis, based on the extent of the problem. It is possible that management of day to day activities will have a greater impact on the levels of condensation than the "engineering" solutions above, although a combination will likely have the greatest affect. Management activities could include the following:-

- Existing Mould growth needs to be completely treated prior to any other activity, in particular redecoration. Regular inspection and removal of initial mould growth will prevent the spread of the mould.

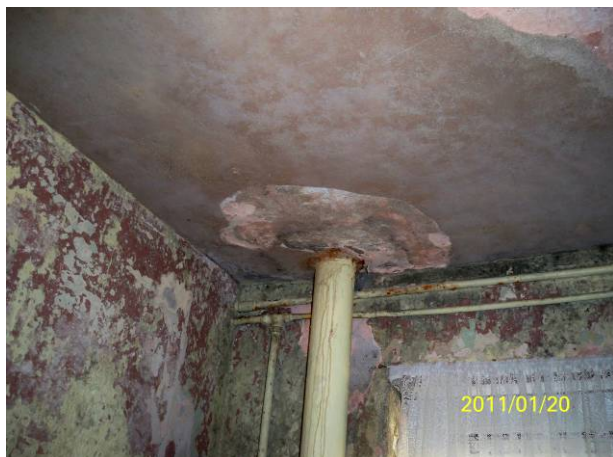
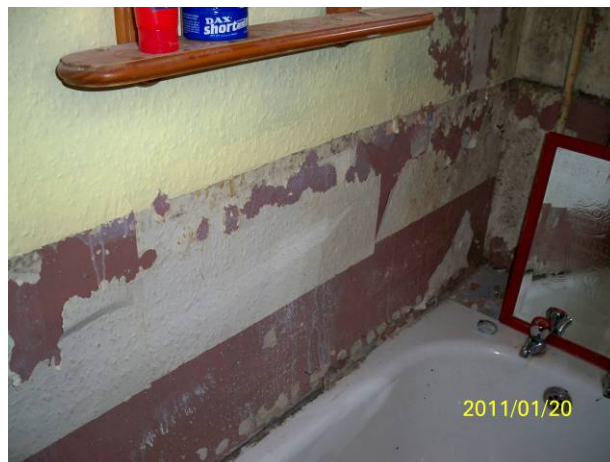
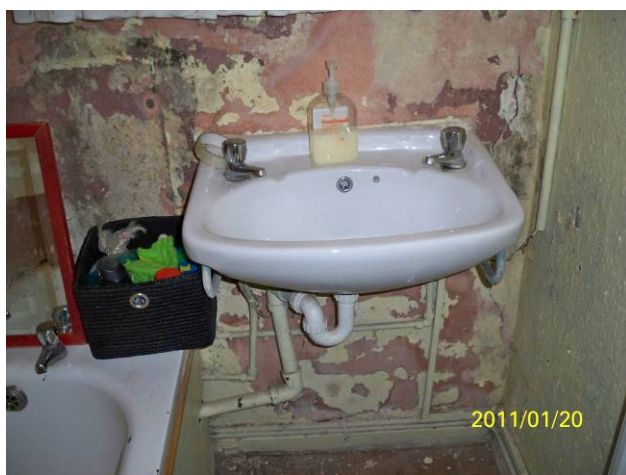
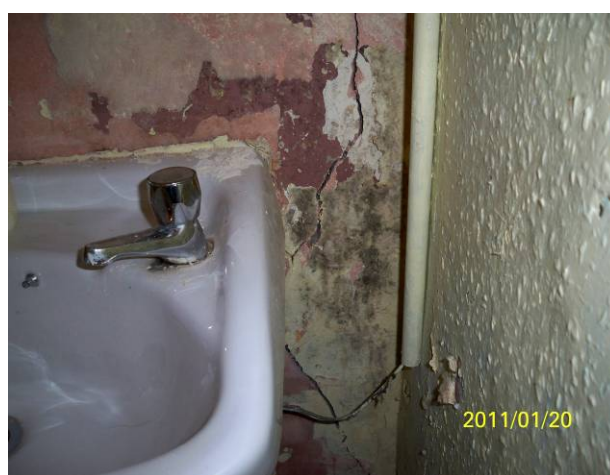
Dublin City Council is addressing a leak which had occurred in the property above Unit No. 83. The following photographs illustrate the current progress which consists of removal of all plaster work to the walls and ceilings. As the bathroom has not fully dried out as yet, it is recommended that this be monitored and further plasterwork removed as necessary. Re-plastering of the room should not commence until such time as the room is adequately dried.

A substantial crack is noted to the side of the sink. It is unknown if this has occurred recently, however it has not extended to the outside blockwork. Dublin City Council has undertaken to monitor this crack.

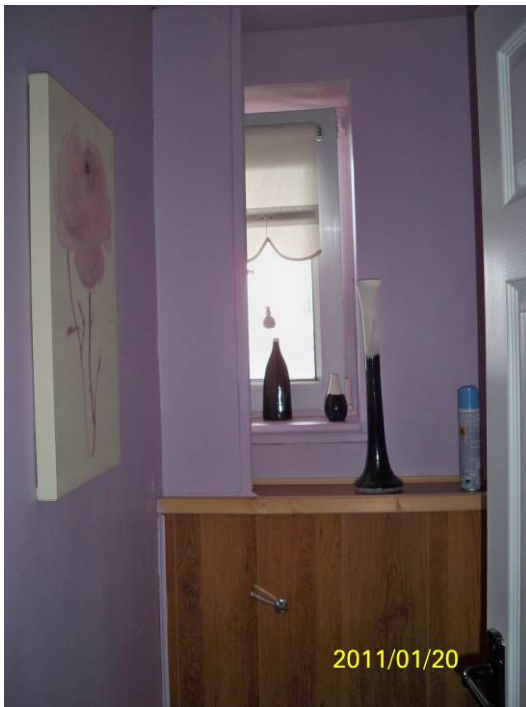
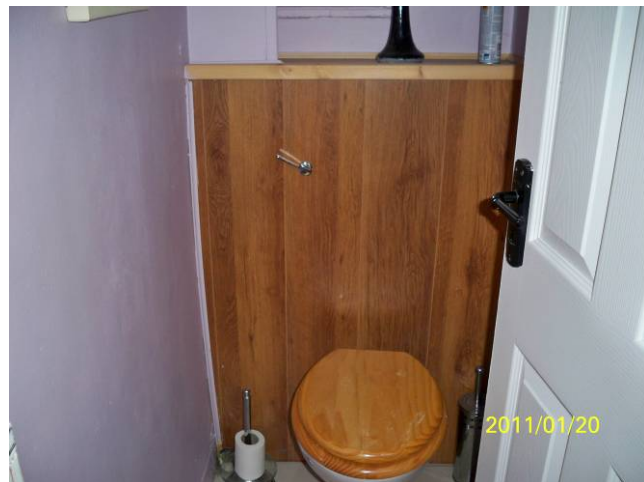
Odour problems have previously been reported in Unit No 36. This unit has been jet cleaned (the individual unit only and not the 4 units discharging to the collection stack). It is encouraging that the Tenant of this Unit has reported that the odour problems have been greatly reduced, if not completely eliminated. This would suggest that the proposed system of jetting and cleaning should solve the majority of odour problems within the complex.

Odour problems were also reported within Unit 40 (which is located above Unit 36). Although this Unit was inspected, no significant odours were noticed at that time. It is recommended this full collection system (of 4 Units) be included in the jetting process.
